**A STUDY ON FAILURE OF EXCAVATOR HYDRAULIC PISTON PUMP**Hidayat Hidayat<sup>\*1</sup>Abdul Muis<sup>2</sup>Abdul Halik<sup>3</sup>Darma Aviva<sup>4</sup>Minir<sup>5</sup><sup>\*1,2,3,4</sup>Mechanical Engineering Department, Politeknik Negeri Samarinda, Indonesia**ABSTRACT**

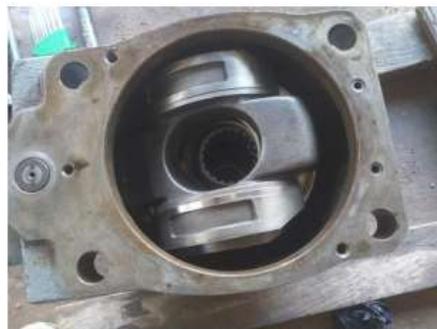
Figure 1. Disassemble Hydraulic Pump Component

Figure 1 shows the disassemble hydraulic pump component. The component of the hydraulic pump was released by using some special tool kit. Then, the swash plate which is used as controller oil flow to the system, was removed from the top surface of the hydraulic pump. Then, the plunger was removed from the cylinder block located inside the hydraulic pump.

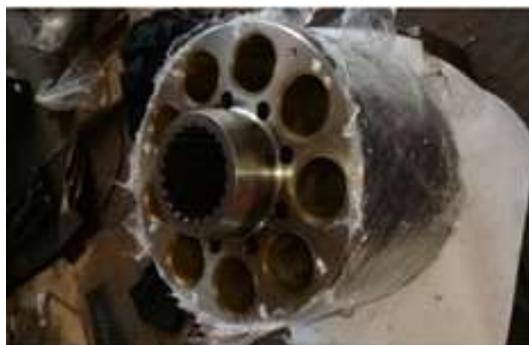
Figure 2. Cylinder Block

The cylinder block in which component of the hydraulic pump used as a house of the driven shaft is shown in figure 2. The cylinder block is also used to compress the oil by plunger and barrel so that the oil from the hydraulic pump has high pressure. Finally, removed all spring which located under the housing of plunger. All components inside the hydraulic pump were investigated by measurement or visual inspection. Measurement of component is the process of observing and recording the observations collected as part of this research. The component was measured to compare with the manual part book in order to define that the component is still reusable or not. As for the visual inspection, the condition of the component was observed by viewing or touching, considering the manual parts book.

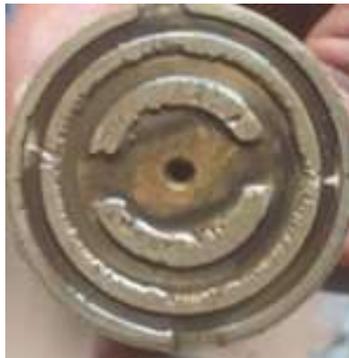
Figure 3. Abrasive wear on piston pump slipper

The abrasion on the piston pump is depicted in Figure 3. Abrasive wear happens most frequently when a hard, rough surface glides across another. In this situation, abrasive wear occurs in this location as a result of contact between the slipper and the swash plate. The swashplate axial piston is a type of hydraulic pump that is frequently employed in heavy equipment. High pressure operation combined with obstruction between the valve plate and the cylinder block results in abrasive wear on the piston pump's slipper.

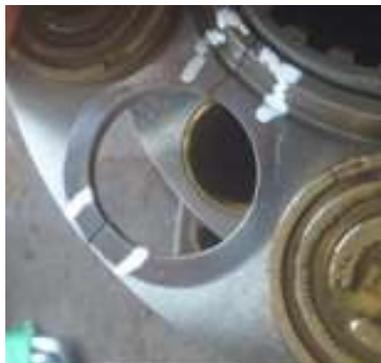
Figure 4. Cracking on slipper retainer plate

The cracking on the slipper retaining plate is depicted in Figure 4. Generally, the slipper retainer cracks as a result of the slipper becoming lodged in the cylinder block. The axial motion of the slipper retainer is related to the piston and cylinder block components.

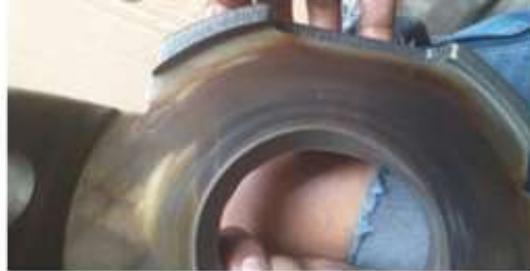
Figure 5. Abrasive wear on a wash plate surface

The abrasive wear on the swash plate is seen in Figure 5. The rotator group of the hydraulic pump includes the swash plate as one of its components. The swash plate angle controls the displacement of an axial piston pump. Abrasive wear is the most prevalent cause of failure with swash plates. The piston's slipper glides across the swash plate's surface. Despite the fact that the piston's slipper is formed of the same steel as the swash plate, there is no carbide separation, and wear is caused by fluid contaminants.
